VIEWPOINT GALLERY

CULTURE SERVICES BUILDING

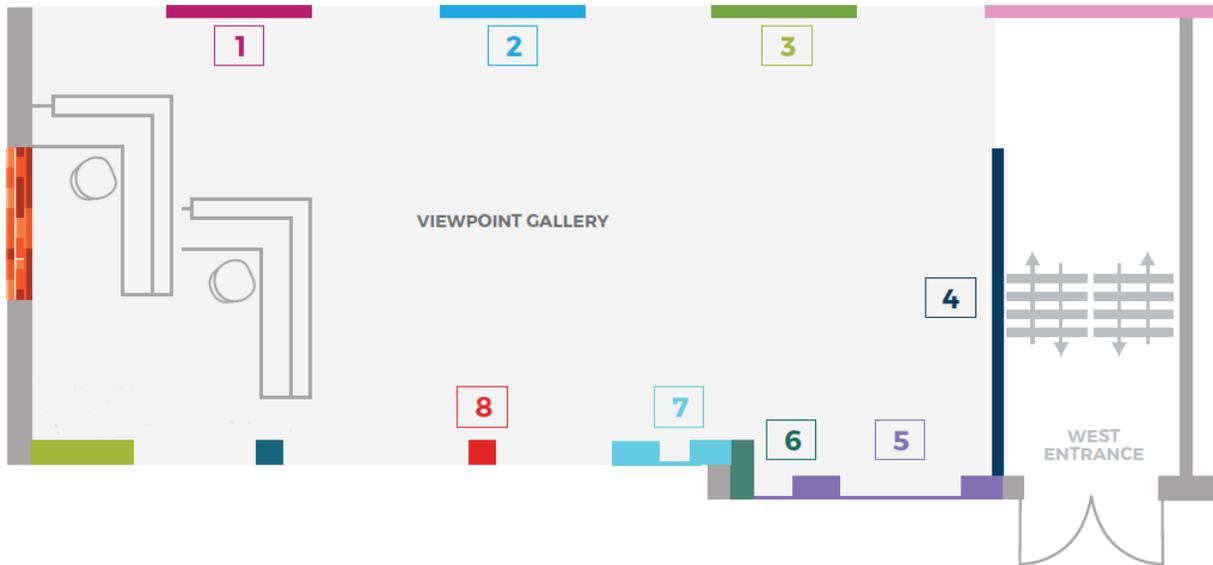
W x H = 93" x 94"

IMPEDIMENTS:

- emergency light fixture 8" down from ceiling
- thermostat and light switches 16 ¾" in from edge of wall
- rubber baseboards, 4 ½" high

OTHER MATERIAL CONSIDERATIONS:

- plywood under drywall - full wall
- opposite side of wall has partial band plywood layer

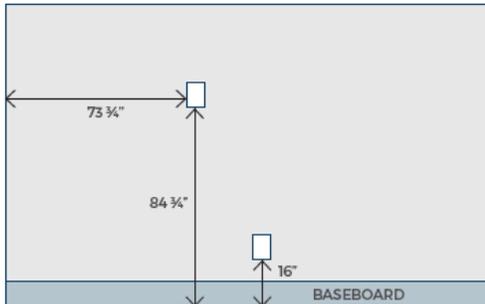
4**W x H = 210" x 126"**IMPEDIMENTS:

- rubber baseboards, 4 ½" high
- fire alarm indicator: is 4 ¾" wide, 84 ¾" up from floor, 74 ¾" in from left wall edge, off centre
- outlet, 16" up from floor in centre of wall

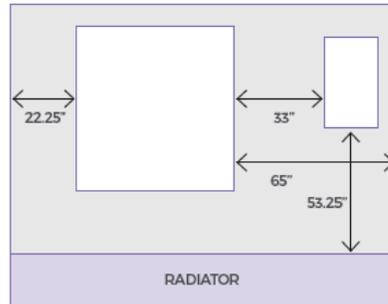
**5****W x H = 160 ¾" x 106"**IMPEDIMENTS:

- radiator - 5" deep, 20" high from floor
- large window + small window, upper right portion of wall

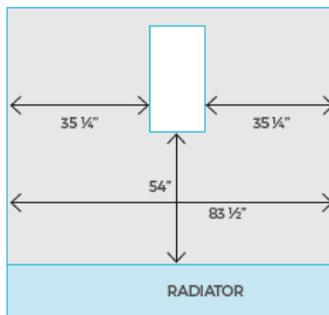
**7****W x H = 83 ½" x 106"**IMPEDIMENTS:

- radiator - 5" deep, 20" high from floor
- window, upper portion of wall
